Throttle Icing: Understanding the Icing Mechanism and Effects of Various Throttle Features

**Julie M. Galante-Fox, Donald E. Jarvis,
Robert D. Garrick and Alfred J. Chen**
Delphi Corporation

**Reprinted From: Advanced Concepts, 2008
(SP-2180)**

**2008 World Congress
Detroit, Michigan
April 14-17, 2008**

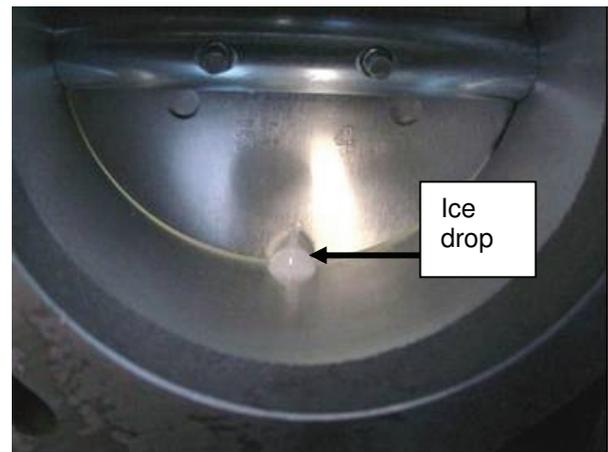
Figure 2. Typical location and appearance of ice from laboratory test No. 1.

Icing Test No. 1 – This laboratory test utilized a freezer set at a constant temperature of -15 °C and fixtures to hold the ETC-ACV parts in a stable, reproducible orientation. To reduce test variability, freezing rate, freezing temperature, water impurities and substrate surface cleanliness were controlled as much as possible [5]. A controlled amount of deionized water (50 microliters) at 25 °C was added using an adjustable volume pipette to the ETC-ACV at the bore / valve interface after cooling the part to -15 °C. The tip of the pipette was placed on the edge of the valve during application of the water. A photograph of a typical ice drop and part is shown in Figure 2. The size of the ice drop was approximately 5 mm wide by 3 mm high.
